Technical Note N-1044

PROTECTION OF FLOATING PONTOONS FROM CORROSION -- PART III.
CONDITION OF TEST FLOATS AFTER THREE YEARS

August 1969

↓
NAVAL CIVIL ENGINEERING LABORATORY
Port Hueneme, California 93041

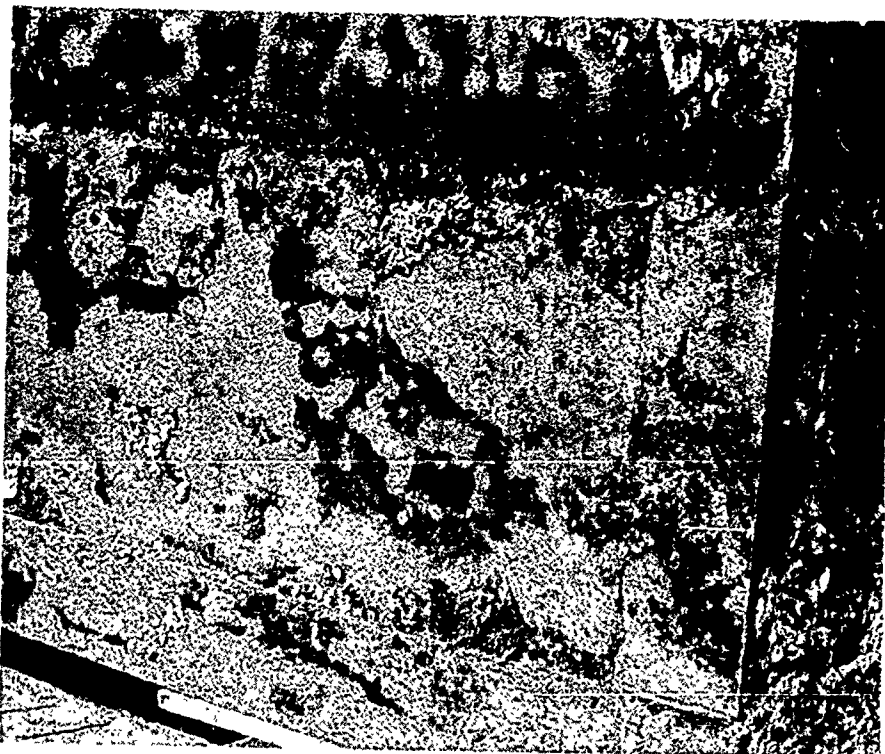
The Navy utilizes about 450 pontoon camel floats of differing size and design in service to the fleet in San Diego Bay. Available camel floats are secured to a centrally-located pier from which they can be readily delivered to ships desiring their use. It has been the standard practice at PWC, San Diego, to protect the steel pontoons from corrosion with a protective coating of MIL-C-18480A, a cold-applied coal tar coating. Because of the rapid deterioration of this coating by abrasion, fouling organisms, and other environmental factors (Figure 1), it has been necessary to recoat the floats annually.

Figure 1. Corroded pontoon requiring recoating.

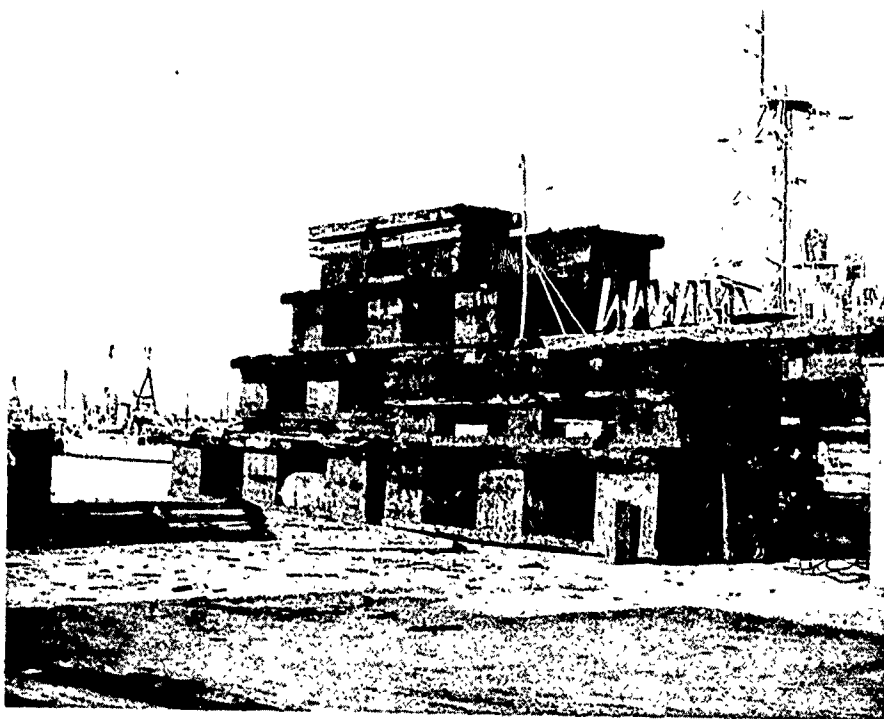
Much of the damage to camel floats occurs below the water line (Figure 2), causing them to sink. Thus, cathodic protection was also investigated in this study as a means of extending the service time of the floats before required overhaul and further reducing maintenance costs.

Figure 2. Deteriorated pontoon camel floats removed from service.

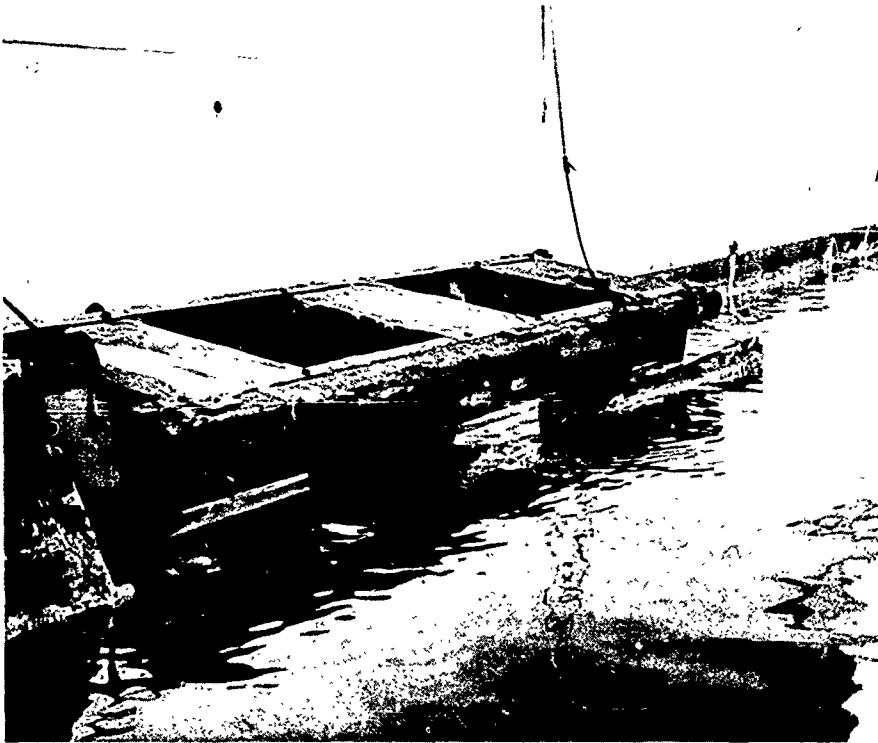
The upper wooden fenders of Float No. 01 were still in good condition, but those located below water had suffered severe marine borer attack at their bolt holes and had been torn partially from the float (Figure 5).

Figure 5. Pontoon No. 01 secured to hull of ship.

3. On floating steel structures rubber fenders should be used underwater in place of wooden fenders subject to marine borer attack.

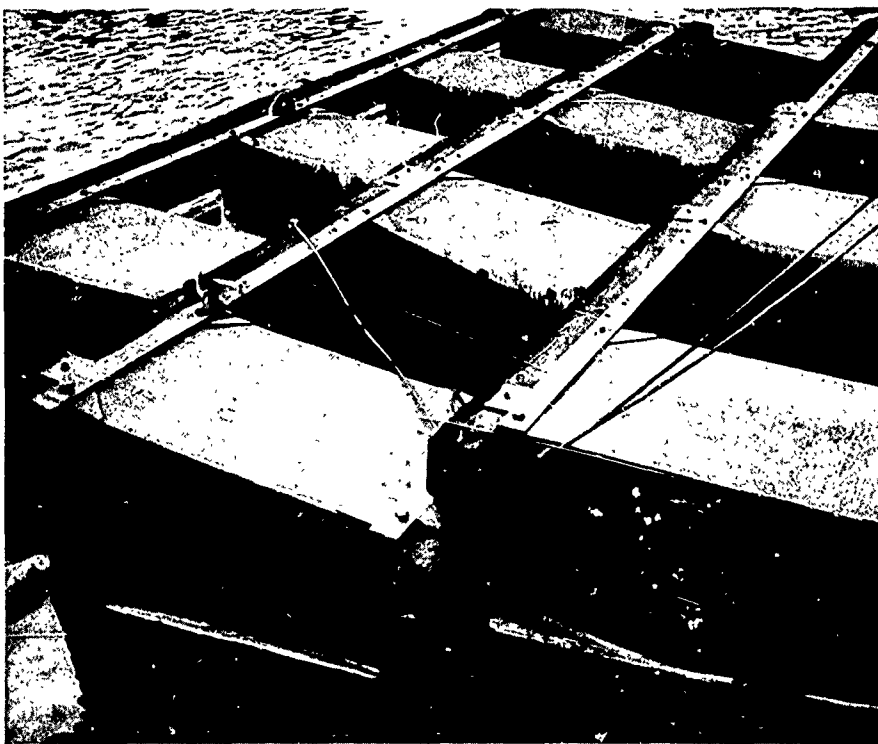
The relatively rapid loss of fenders below water is caused by marine borer attack where untreated wood is exposed at cut ends (Figure 6) and at bolt holes. This can be avoided by making the necessary cuts before treating the wood (e.g. pressure creosoting). Probably a much better system is to use hard rubber fenders rather than wooden ones. Such fenders are available in a variety of sizes and shapes and have performed well on mooring buoys both above and below water.²⁵ They are resistant to marine biological attack and absorb impact and abrasion better than do wooden fenders.

3. Treated lower fenders on floats and mooring buoys are readily susceptible to marine borer attack unless they are treated after all cuts have been made.

Figure 6. Untreated wood exposed at cut ends of camel fenders.
